ADAS Vision Risk Assessment

December 11th, 2022

M.L. Cummings
Benjamin Bauchwitz
Yunseon Kang

Duke University

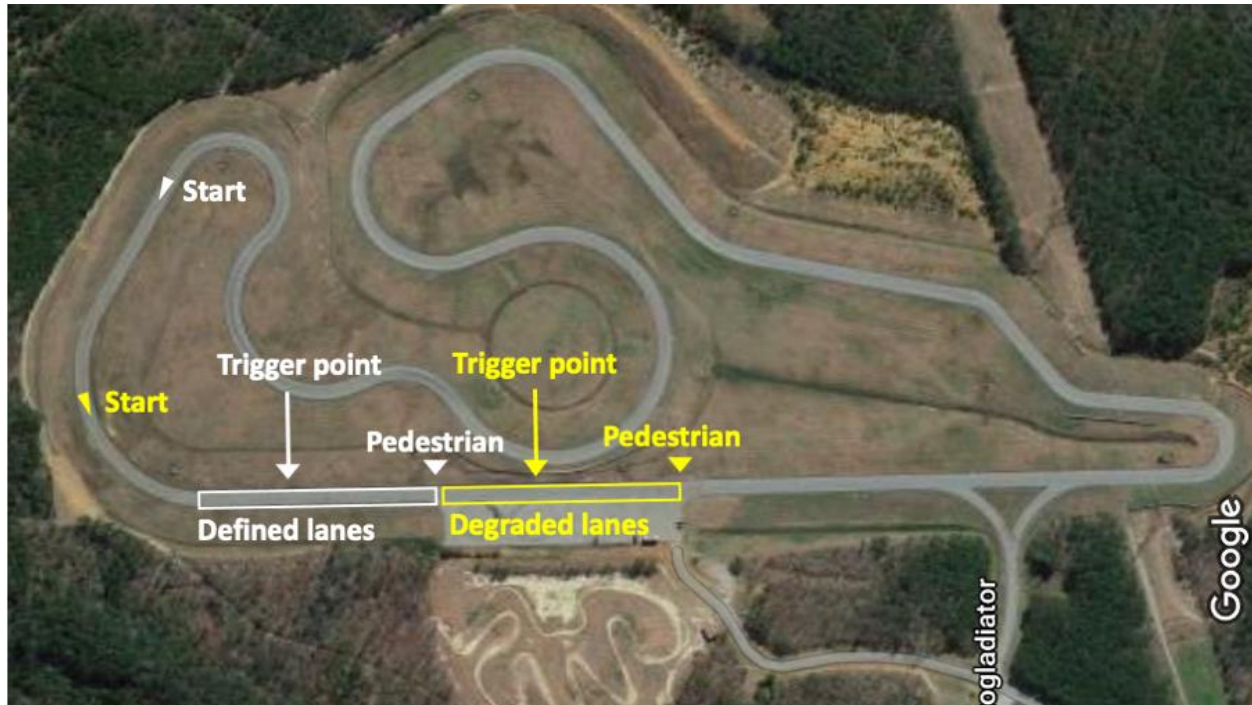
Figure 2: Pedestrian test environment. Defined lanes are marked in white and the degraded lanes condition are marked in yellow.

Each trial consisted of driving one of the six vehicles on a 1,500-foot section of track (Figure 2) at the North Carolina Center for Automotive Research (NCCAR), a closed test track facility. The roadway is 40 feet wide, which was then separated into three 13-foot-wide lanes. All cars experienced regular lane line trials, which were standard 10-foot by 6-inch lines with 30-foot longitudinal spacing, as specified in the Manual on Uniform Traffic Control Devices. They also experienced a degraded lane line condition, where longitudinal marks were present but were shorter sideways C-shaped lines and irregularly spaced (Figure 3) 600 feet from the pedestrian. All trials for this test were conducted in a high sun angle condition (sun altitude > 40 degrees).

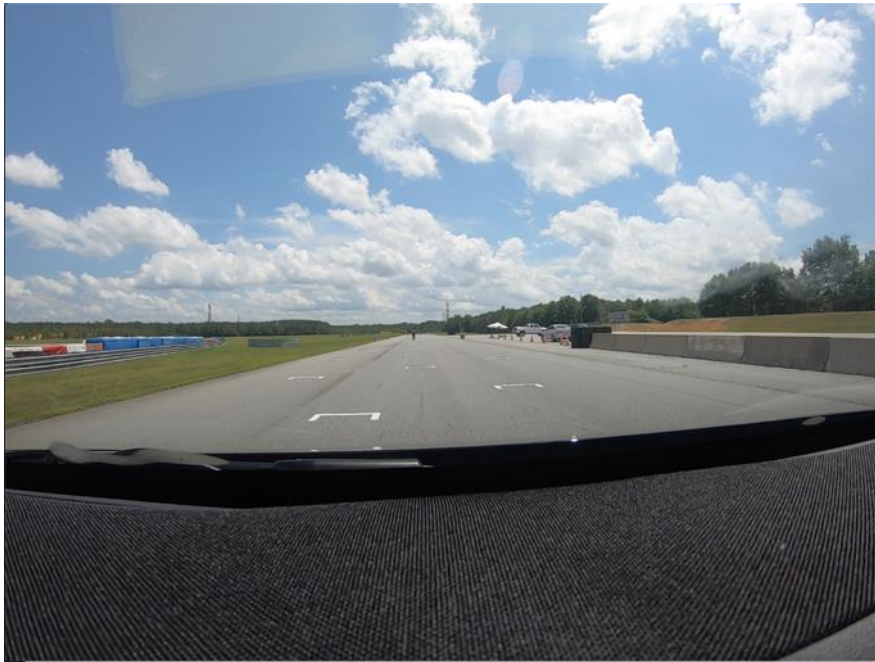
Figure 3: Degraded lane marking appearance

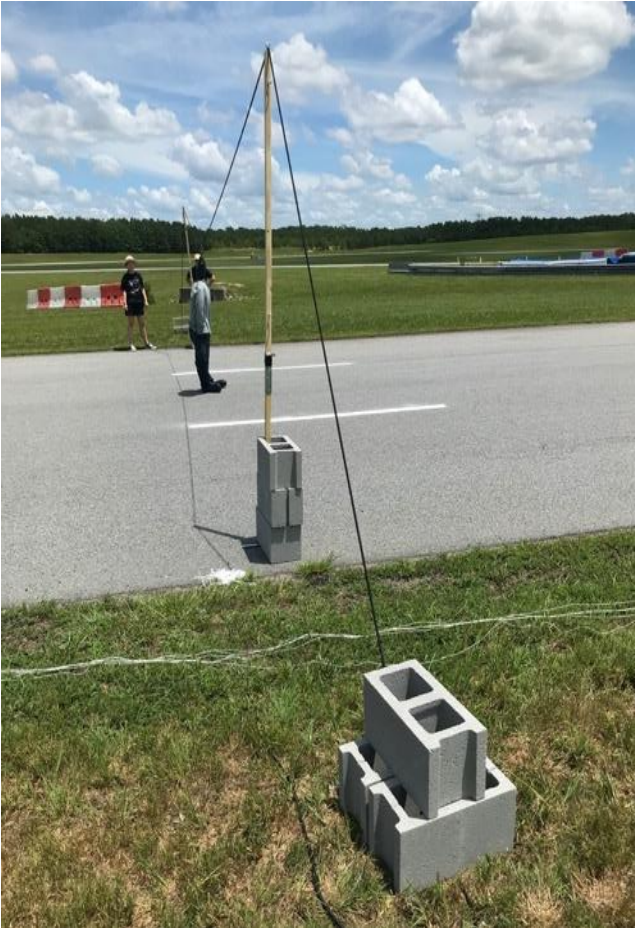
Figure 4: Pedestrian test environment layout

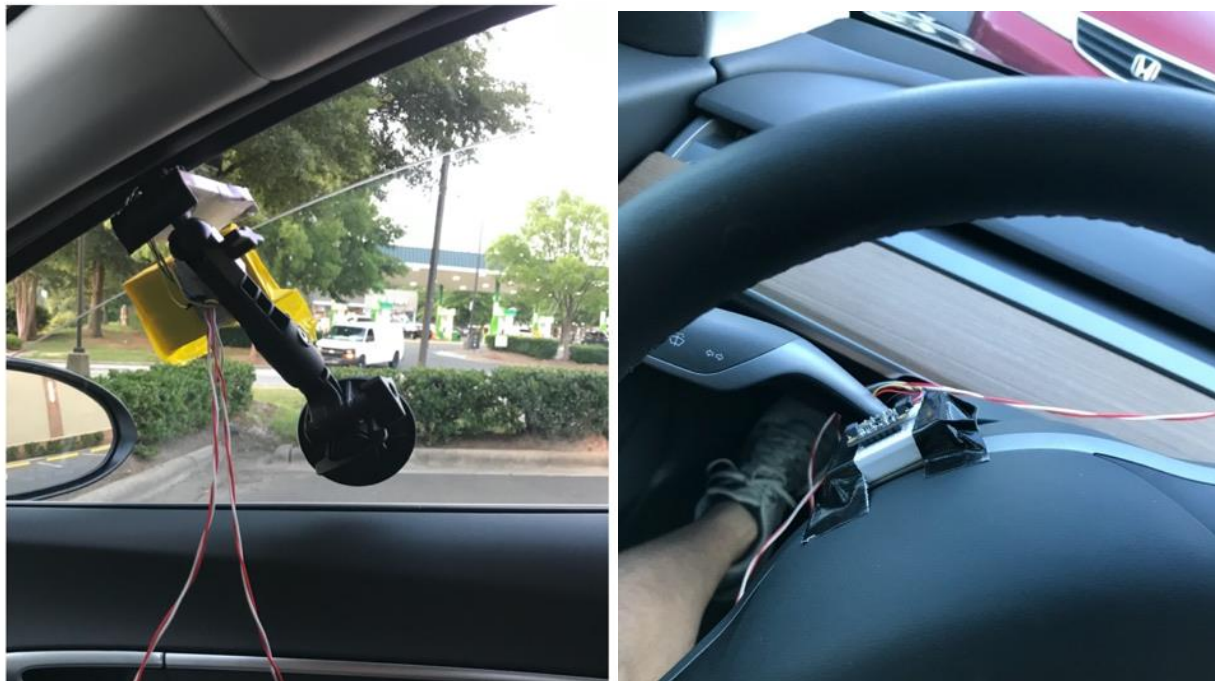
Figure 5: Sensor components. Left: ambient light sensors. Right: acceleration and rotation sensor

The second component consisted of an Adafruit VEML7700 ambient light sensor mounted on the outside of the passenger-side window (Figure 5). The ambient light sensor collected data on raw luminosity as well as white light saturation. The light sensor measures ambient light and was calibrated to detect changes in high light intensity corresponding to direct sunlight. Each sensor communicated over a wired connection with an Adafruit Metro microcontroller (a variant of the Arduino Uno) placed within the vehicle and synchronized using the I2C communication protocol. The sensor array was synchronized with the cameras by using a sound cue that was presented when the sensors turned on and turned off, which was audible to each of the cameras.

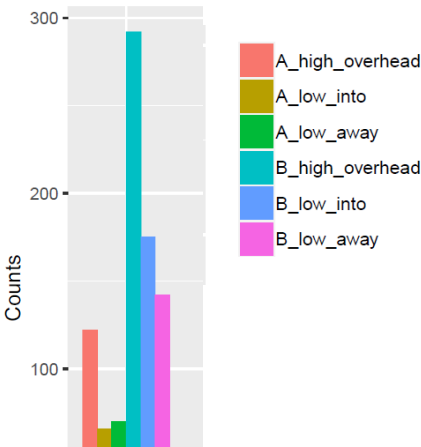
Figure 6: Counts of events separated by car and sun angle

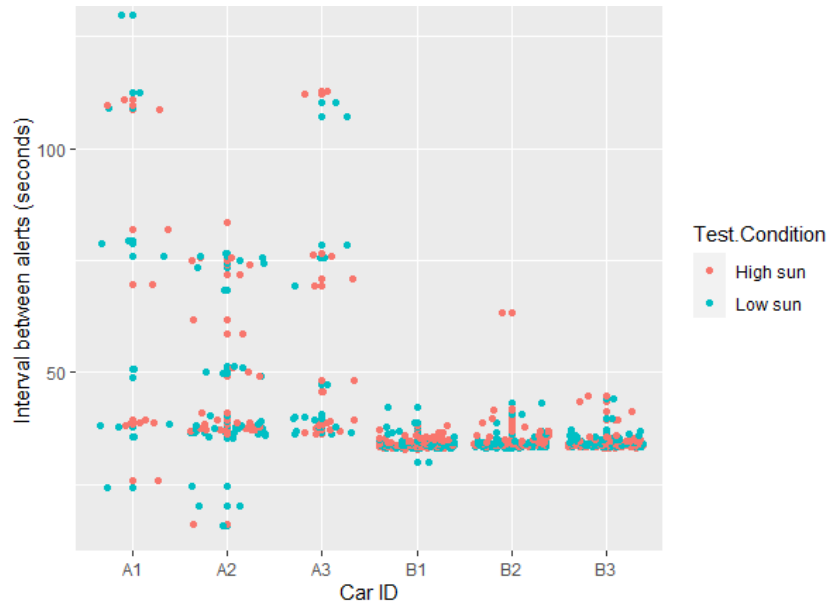
Figure 7: Hands-on-wheel intervals by individual car and sun angle

Model B intervals were tightly grouped around 34 seconds (SD = 2 seconds). Unlike Model B, Model A vehicles had much more spread in the intervals between alerts, with an average interval of 52 seconds (SD = 24 seconds). Compared to Model A, Model B intervals were much shorter. This is why Model B vehicles produced more alerts than Model A, as seen in Figure 8 and Table 6. Interestingly, Model A intervals appeared to be in three distinct interval bands around 35 seconds, 75 seconds, and 110 seconds. We could not determine any factors that might explain these bands.

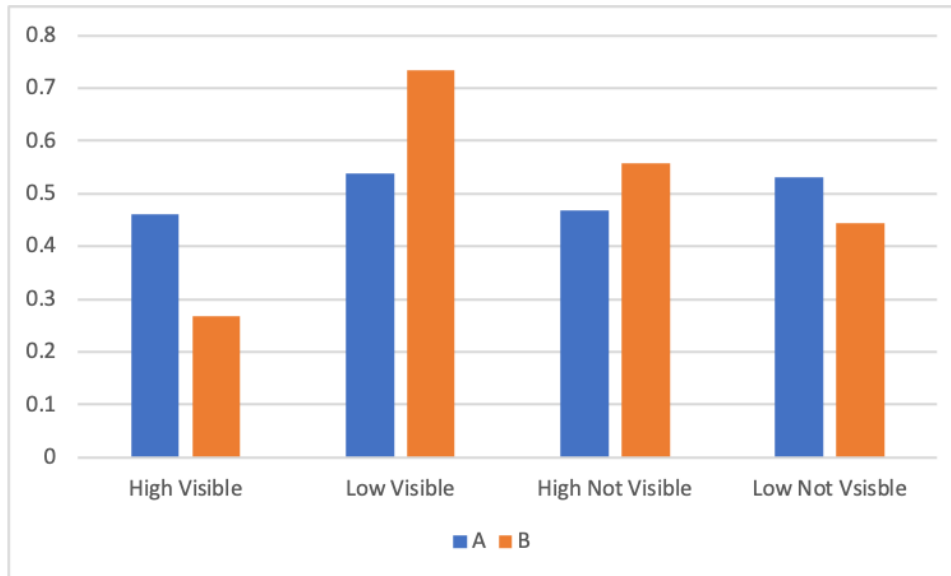
Figure 8: Percentage of Hands-on-Wheel alerts in the low and high sun angle groups where the sun was and was not visible

Figure 8 illustrates the percentages of HOW events when the sun was and was not visible for the two different car brands, categorized by the experimental sun angle condition. A chi square test looking at whether the number of alerts for Model A under low and high sun angles is independent from the visible versus not visible sun variable, the chi-square statistic = 0.007, $p = .93$ so there were no dependencies. For Model B, the chi-square statistic = 40.7, $p < .00001$, meaning the Model B HOW alerts were influenced by both sun angle and whether the sun was visible. Thus, Model A cars were generally consistent in their alerting, and Model B was more variable. Given the increased alerting frequency of Model B, to better compare the variability in HOW alerting for Model A and B vehicles, Figure 9 shows the z scores for each of the vehicle's HOW occurrences, which normalizes each car by its unique class mean and standard deviation. It also distinguishes between events where the sun was and was not visible.

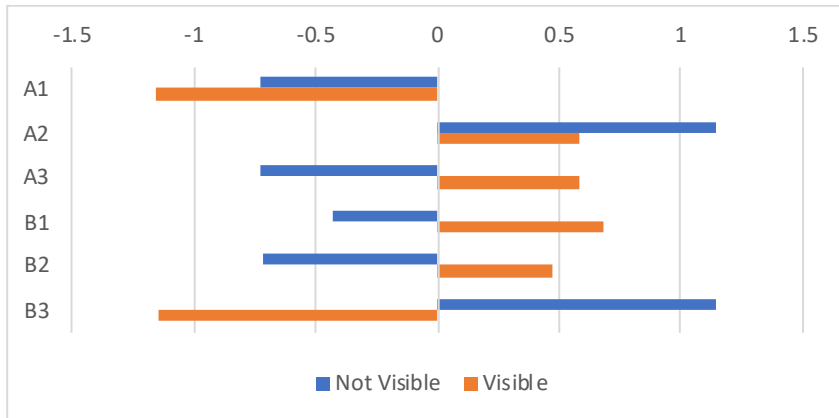
Figure 9: Normalized z scores for individual vehicles by their model average

Cars A1 and A2 were consistent across both sun settings. Model A vehicles as a group were slightly less variable than Model B cars with the sun visible, while Model B cars were less variable when the sun was not visible. It should be noted that overall variability across both model groups was lower in the cases where the sun was not visible, suggesting that sun glare could have an important effect on HOW alerting.

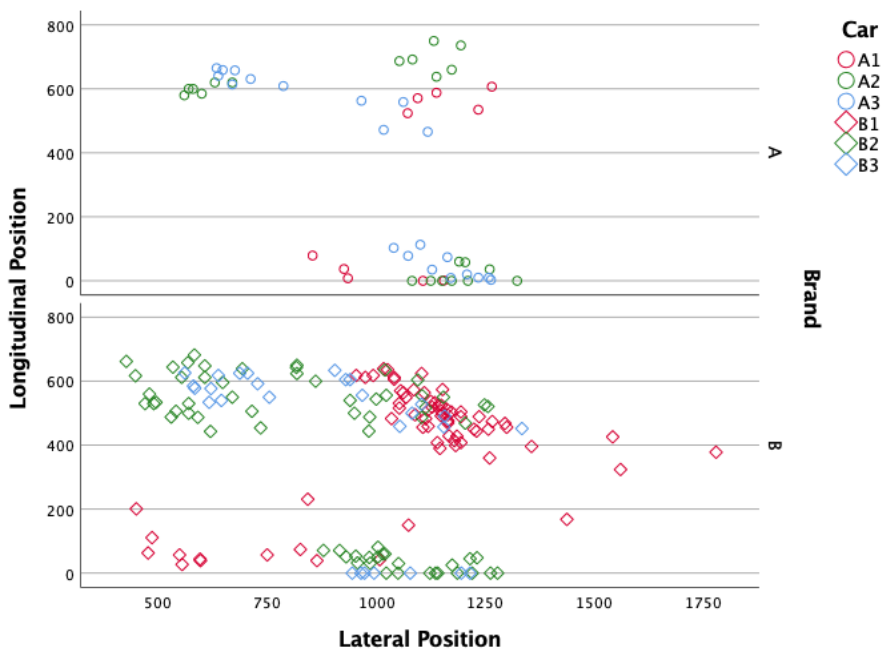
Figure 10: Lateral and longitudinal position of the visible sun when a hands-on-wheel alert sounded

To further determine any effect of sun glare, we examined every HOW event with the sun visible in the forward field to determine if there were any differences in the horizontal and vertical positions of the sun when an alert was generated. Using the lower left of the windshield as the 0,0 position and normalizing between cars, we plotted the pixel position of the sun for every HOW event per car with a visible sun. The results are shown in Figure 10, while Figure 11 shows the averages.

The significance for the overall sun angle from low to high was expected, as this was core to the experimental design. Figure 10 illustrates that all cars experienced alerting in the lateral direction in a similar pattern; however, Car B1 suffered the widest difference at almost 500 pixels difference to the right, also confirmed in Figure 11. This is important because Car B1 had a slightly higher location for alerting under high sun angle conditions, but also lower than all other cars in the low sun angle position, and is the primary driver behind the significant statistics in the MANOVA.

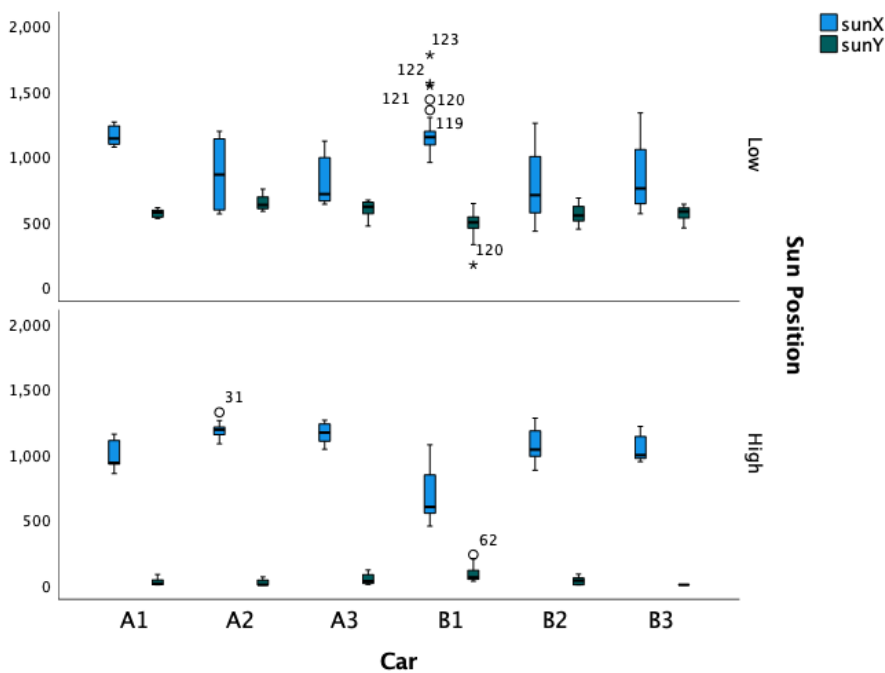
Figure 11: Sun position by individual car and sun X/Y for HOW events with a visible sun

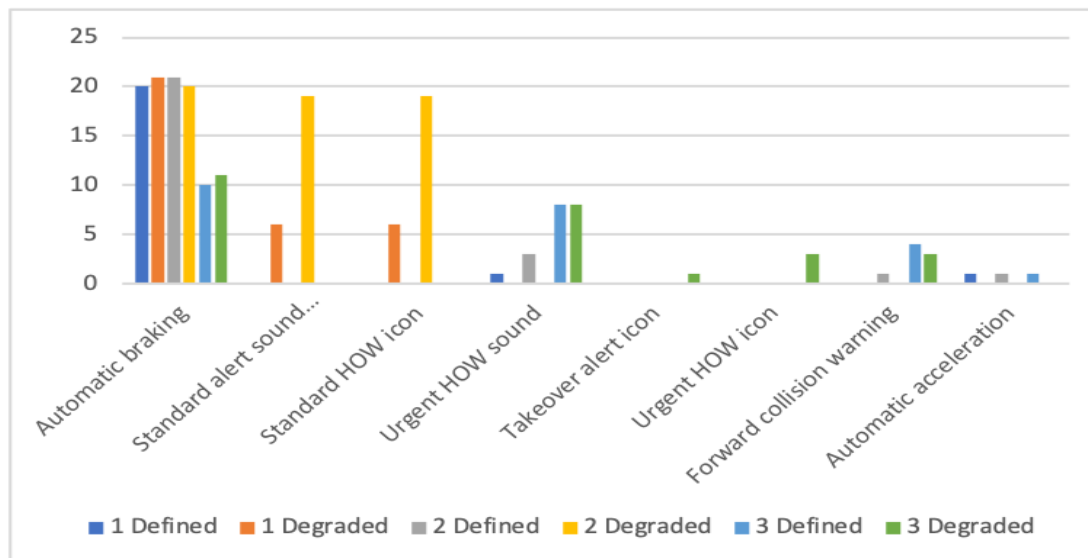
Figure 12: Counts of Model B events by individual car and lane condition

Error! Reference source not found. shows the counts of events in Table 7 for defined and degraded lanes per car for all events except pedestrian visualizations, which will be analyzed further in a later section. Automatic braking was very consistent for cars B1 and B2, but Car B3 only braked in about 60% of all trials. It is especially noteworthy that Model B cars only provided standard HOW visual and aural alerts in the degraded lines conditions, with Car B2 providing 3 times the standard visual and aural alerts of Car B1. These alerts seemed to be commensurate with the automatic braking events, but only for Car B2.

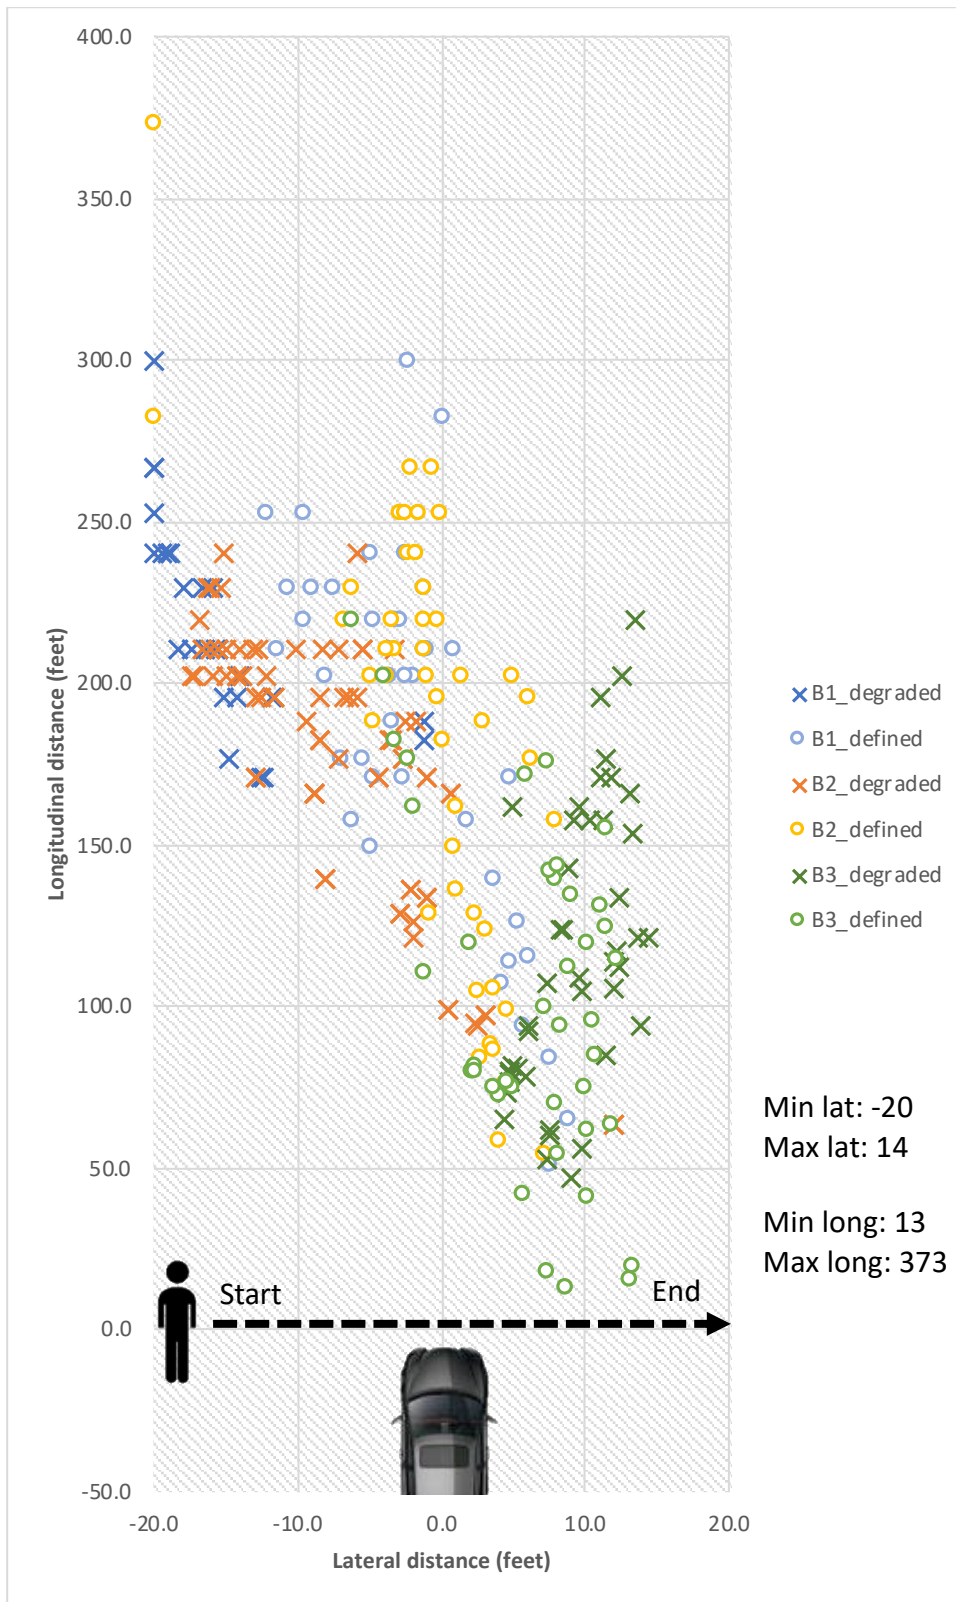
Figure 13: Relative position of pedestrian target to vehicle when pedestrian icon appeared in Model B console

Figure 13 shows the position of the inflated pedestrian, relative to the vehicle, when the pedestrian icon appeared on each car’s display. Longitudinal distance is the distance in feet from the car’s bumper to the pedestrian. Lateral distance is defined relative to the vehicle centerline (which was centered on the roadway), with -20’ at the far-left edge of the road and +20’ at the far-right edge of the road. Since the pedestrian detection crossed the road from left to right, an early detection of the pedestrian occurs with larger longitudinal distances and negative lateral distances (closest to the left edge, where the pedestrian began its movement). Small longitudinal distances and positive lateral distances indicate that the pedestrian was detected later.

When comparing the estimated marginal means for the data in Table 8 through pairwise testing using a Bonferroni adjustment, for both the lateral and longitudinal cases, cars B1 and B2 are statistically no different, but Car B3 is ($p < .001$ for all comparisons with an alpha = .017 for a familywise error correction). The longitudinal comparison between defined and degraded lanes was not statistically significant at $p = .026$ but it was for the lateral data ($p < .001$). All this means that there was not likely a measurable difference in where the pedestrians were detected longitudinally by the different cars, but there was laterally with Car B3 performing very differently than Cars B1 and B2. It should also be noted that cars B1 and B2 both detected the pedestrian *earlier* in the degraded line conditions, by on average 7 and 9 feet respectively. However, Car B3 detected the pedestrian in the degraded lane lanes, on average, 4.5 feet after the defined line conditions. However, the most dangerous, i.e., late, detections happened primarily for Car B3 in the defined lanes condition.

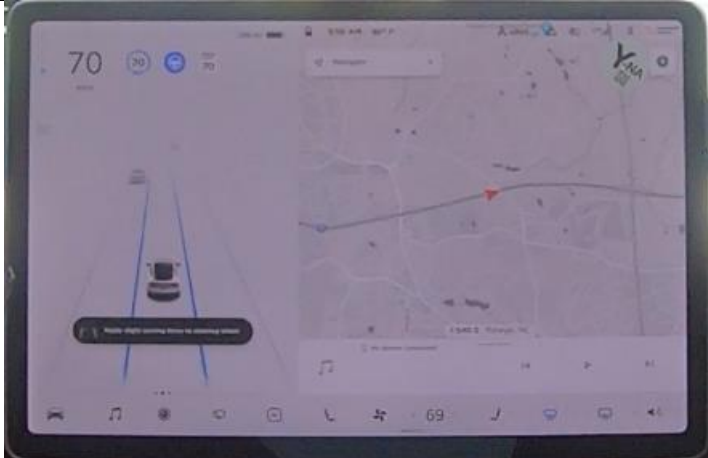
Event ID	Event Name	Picture
E1	Grey standard hands-on-wheel icon

Table 10: Car console pictures of Model B when events happened

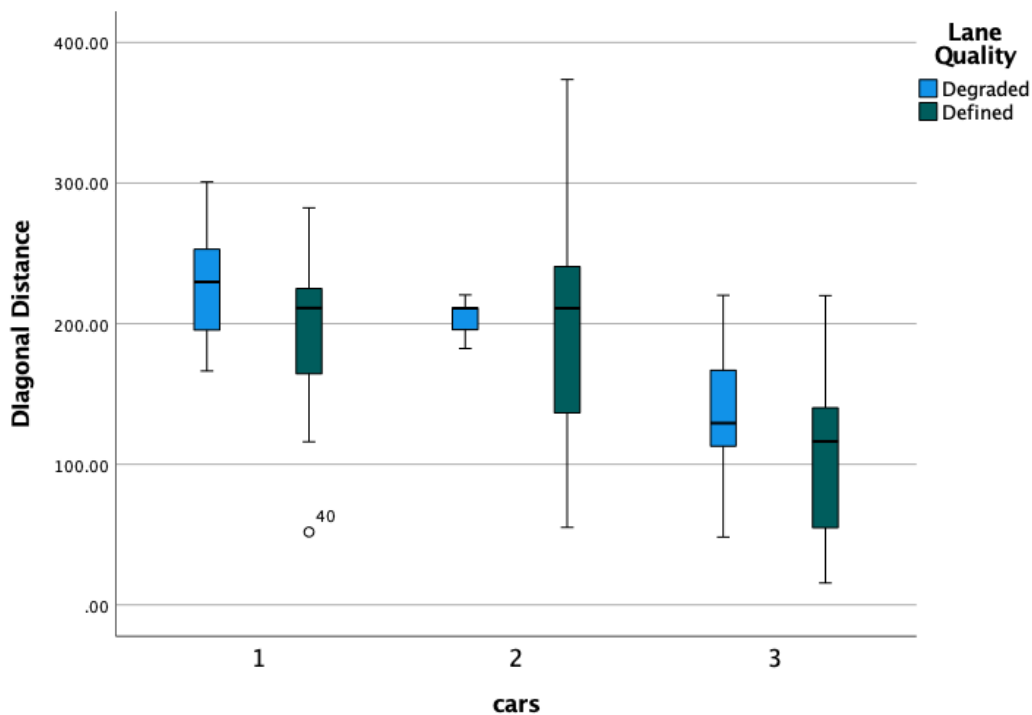
Figure 15: Diagonal distance when pedestrian alert appeared by individual cars of Car Model B

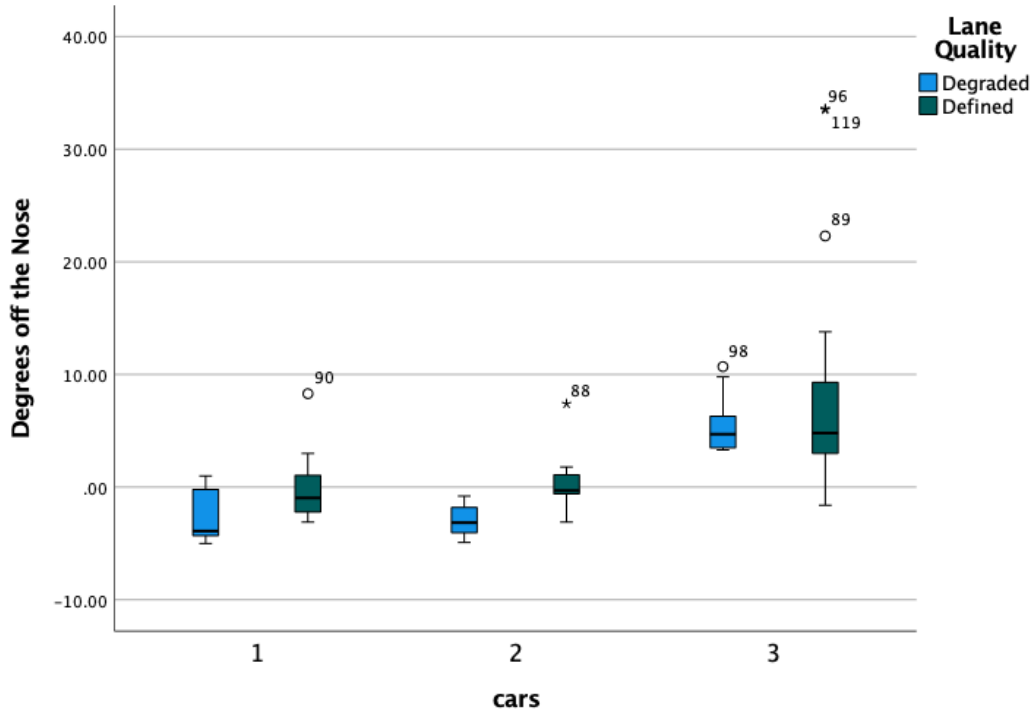
Figure 16: Degrees off the nose when pedestrian alert appeared by individual Model B cars

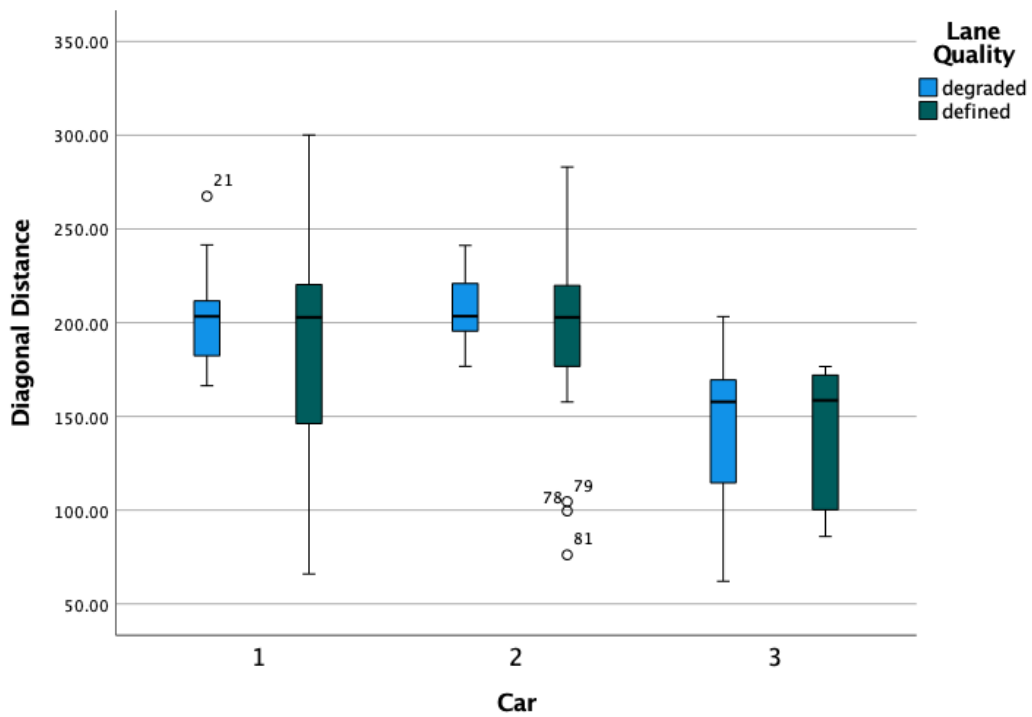
Figure 17: Diagonal distance when automatic braking occurred

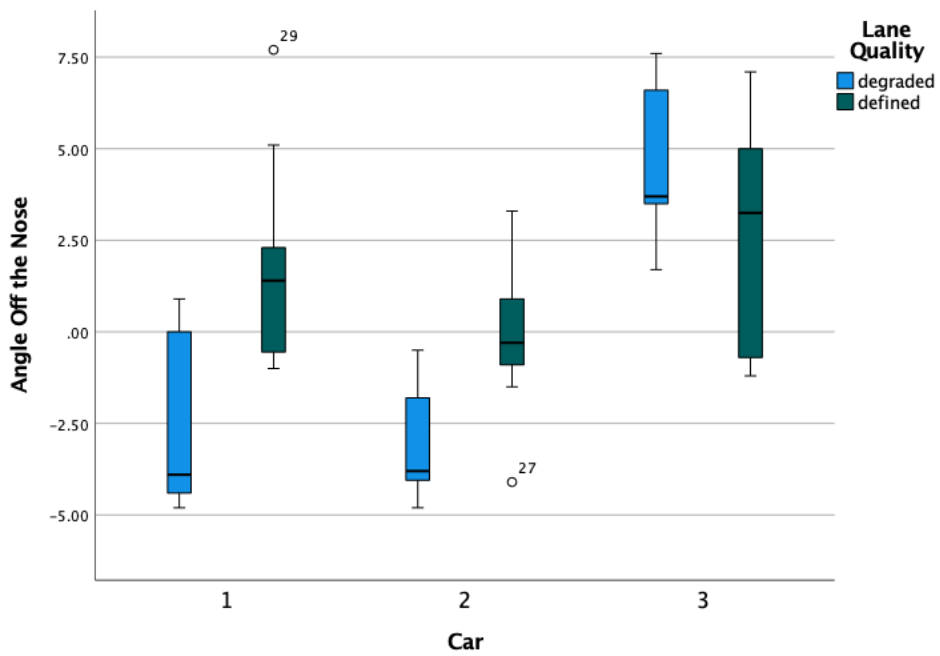
Figure 18: Degrees off the nose when automatic braking occurred

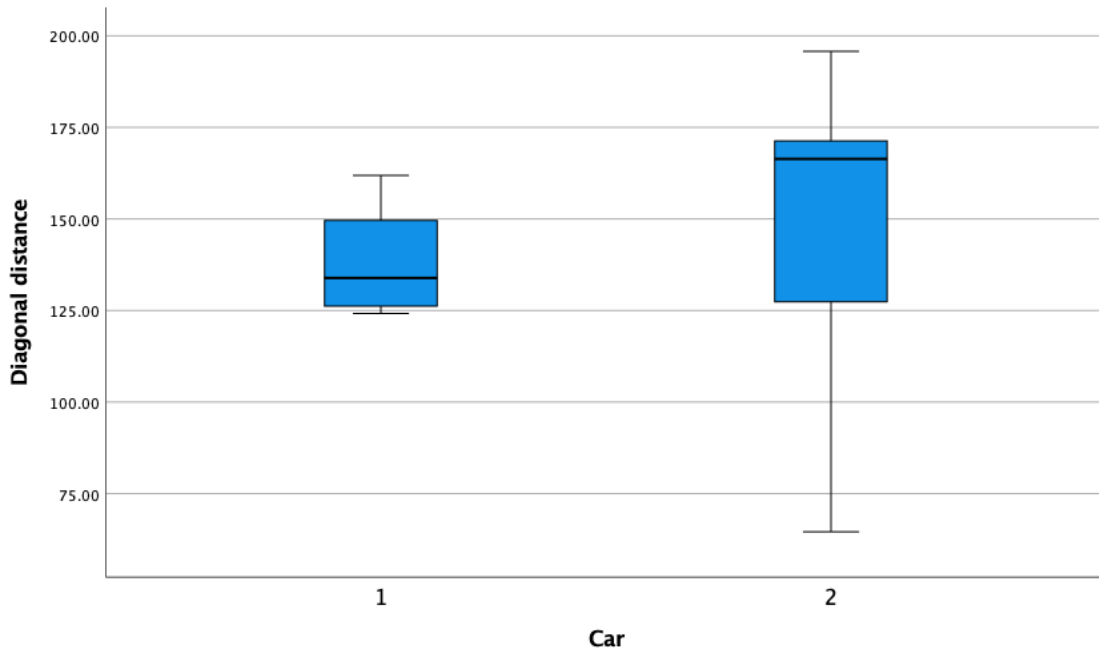
Figure 19: Diagonal distance of pedestrian when hands-on-wheel/double chime occurred

Only B1 and B2 had hands-on-wheel or double chime alert with 6 cases of B1 and 19 cases of B2. Also, those happened only in degraded lanes.

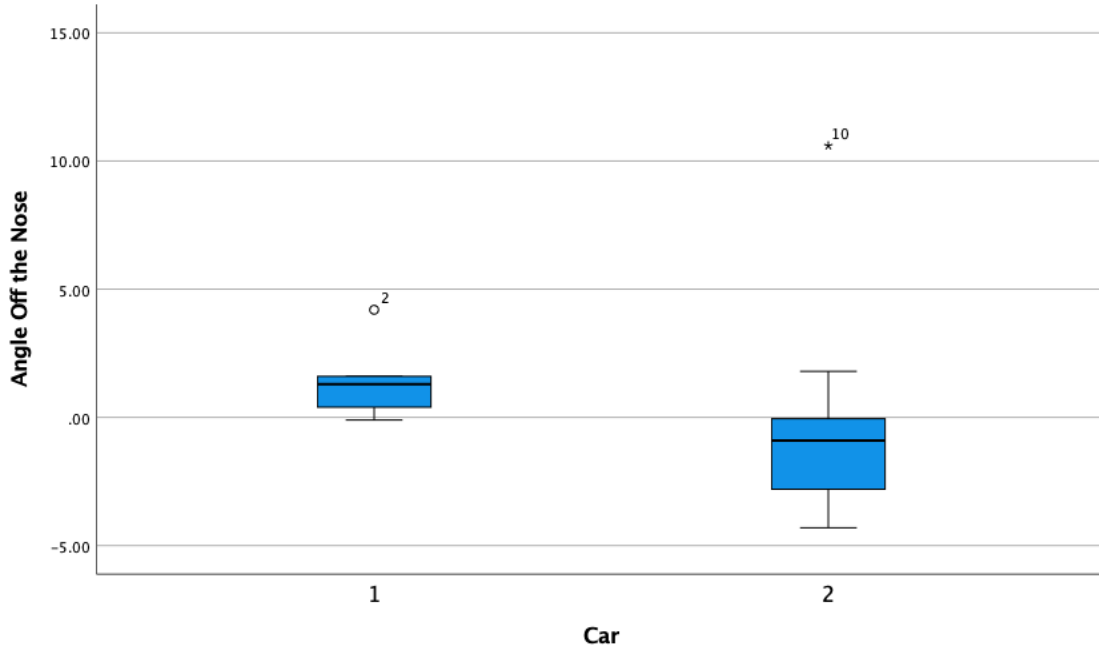
Figure 20: Degrees off the nose when hands-on-wheel/double chime occurred

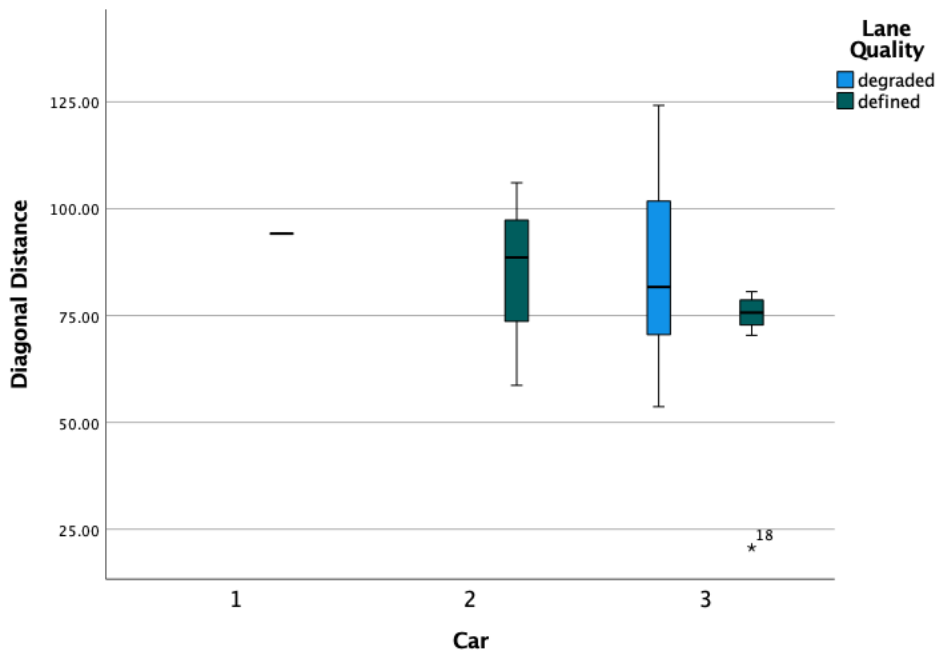
Figure 21: Diagonal distance when rapid alert appeared

Only Cars B2 and B3 experienced rapid alert cases, and they always happened to the right of the nose.

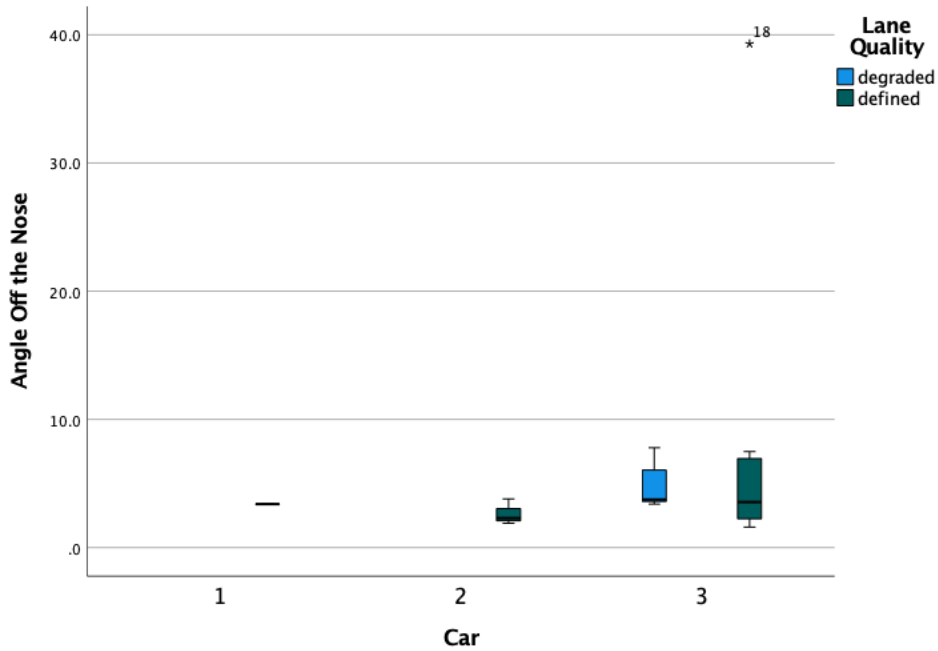
Figure 22: Angle off the nose when rapid alert appeared

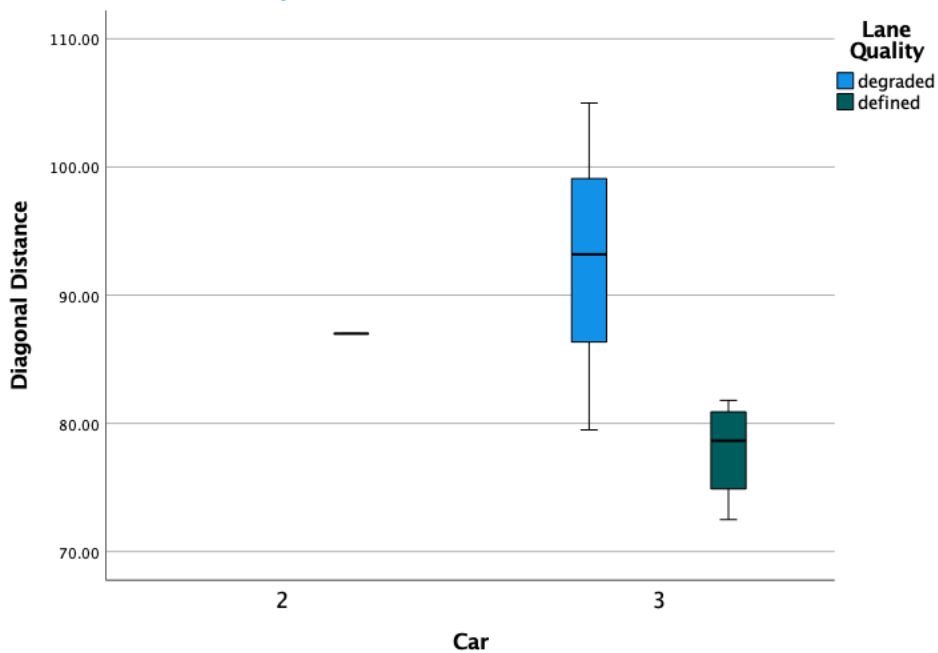
Figure 23: Diagonal distance when the forward collision warning happened

There were only Car B2 and B3 observations. The pedestrian was always to the right of the nose when a forward collision warning occurred.

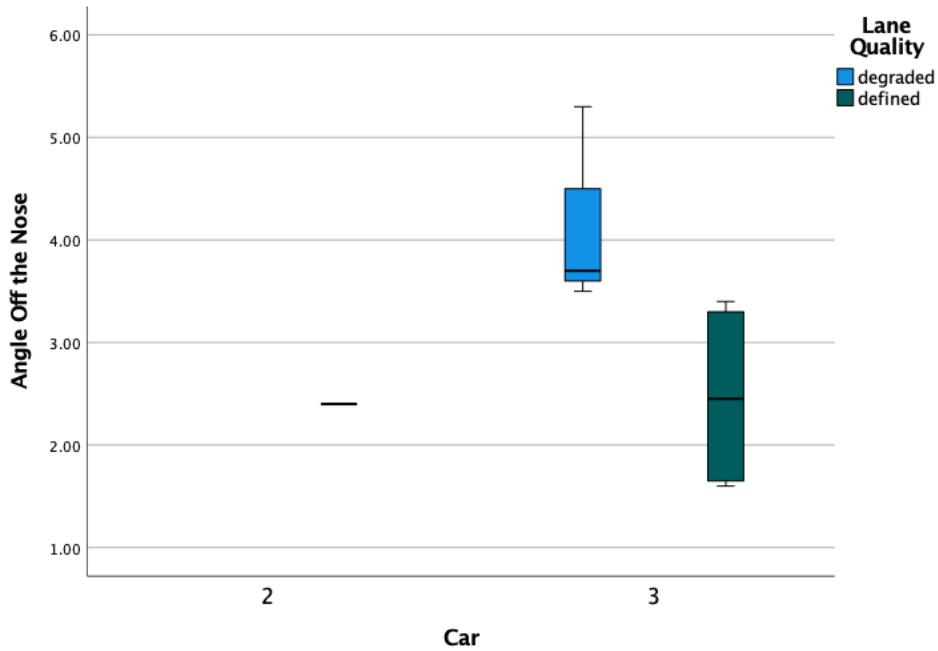
Figure 24: Angle off the nose when the forward collision warning happened

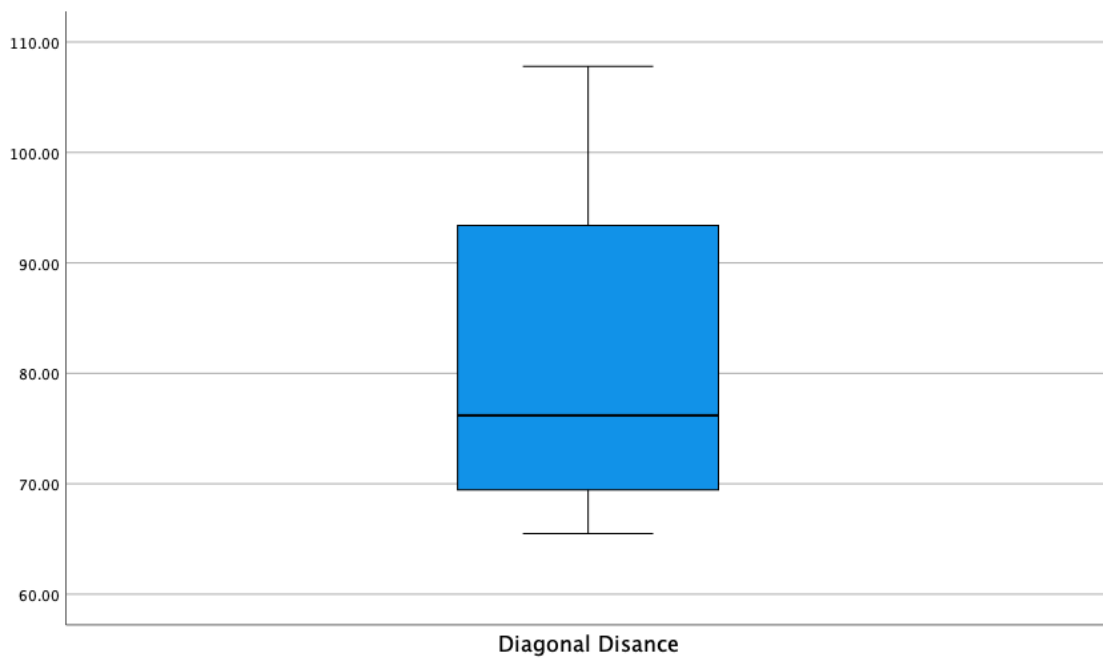
Figure 25: Diagonal distance when driver and final takeover appeared

Only Car B3 had driver and final takeover alerts, and in the degraded lanes condition. At 40 mph (59 ft/s), the forward collision warning/rapid alert/final takeover alerts happened on average 67-92 feet away, giving the pedestrian 1-1.6 seconds to clear; these were very close calls.

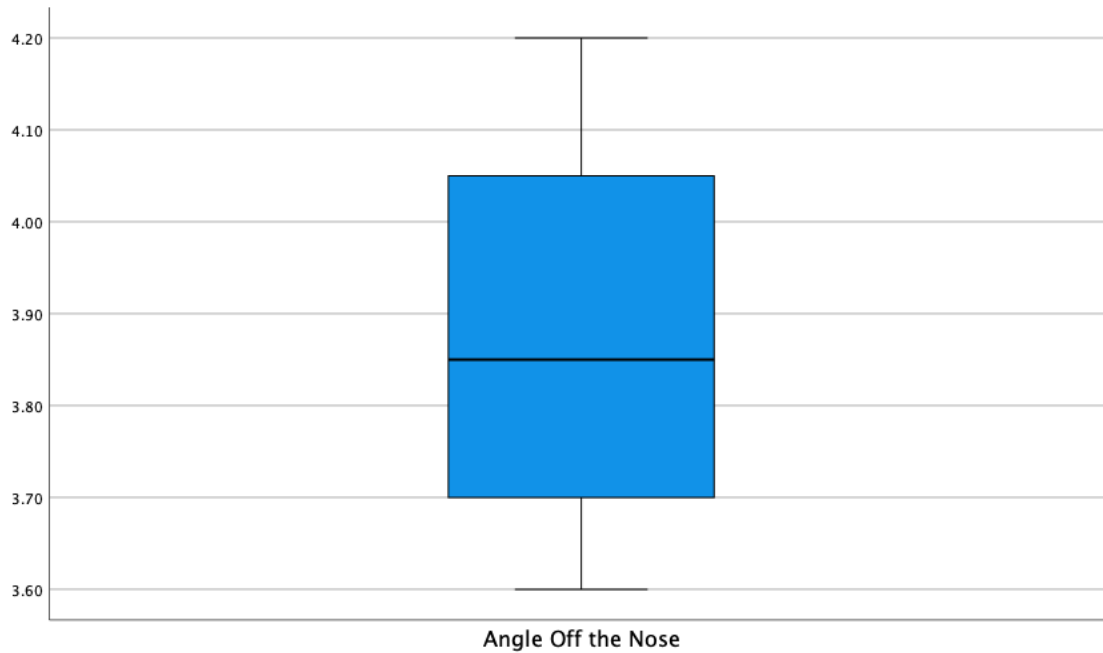
Figure 26: Angle off the nose when driver and final takeover appeared
